## Introduction

During the week of September 29, 1980, Region VII EPA received a report of possible cyanide gas poisoning of workers at the Collis manufacturing plant in Clinton, Iowa. Workmen involved in the dredging of the sludge disposal pits at Collis noticed a strong ammonia smell in one of the pits and within two hours developed headaches and nausea. One of the workmen reported the incident to the Iowa Department of Environmental Quality (IDEQ) who, in turn, forwarded the complaint to EPA and the Iowa Department of Labor. FIT personnel were requested (TDD F-7-8010-4) to perform a preliminary assessment and site inspection of Collis Corporation to determine if the facility's waste management practices were adequate for the protection of the environment and public health. Therefore, on November 13, 1980, the Region VII Ecology and Environment FIT team conducted an inspection of Collis Corporation. Mr. Virgil Showerman, plant manager, and Mr. Nello Arterburn, plating supervisor, were interviewed during this inspection; after which, several samples were collected from Collis's waste treatment system. The results of this inspection are summarized in the following report.

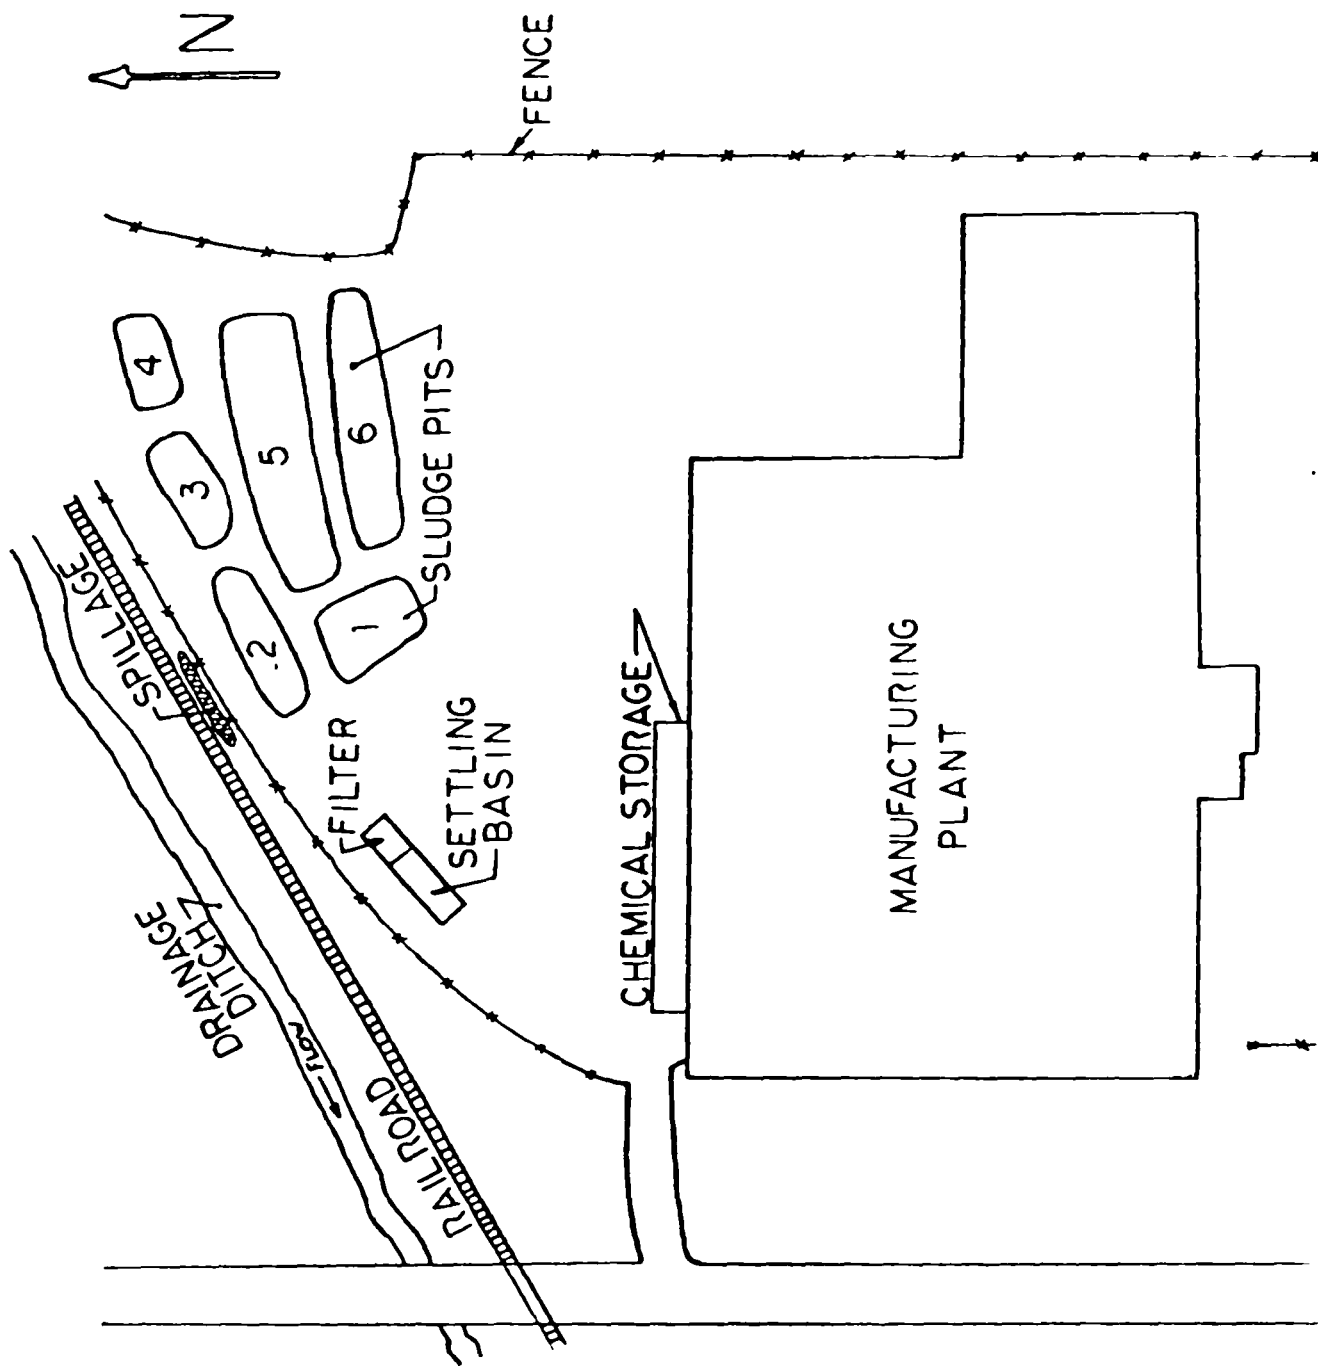
Figure 1. Sketch of Collis Manufacturing Corporation, Clinton, Iowa

Between 1971 and 1980, the sludge was placed in six sludge disposal pits located on the facility property (Figure 1). During this nine year period, approximately 1000 cubic yards of sludge were placed in these pits. Since the latter part of September, Collis has been removing the sludge from these pits and hauling it to the Rockford Browning Ferris landfill.
